## Renoteck Management Report

Your Company  
General Store  
1234 Avenue, Calgary, AB

**General Store  
1234 Avenue  
Calgary, AB**

**Section:** Main Roof  
**Size:** 121,979  
**Overall Grade:** C

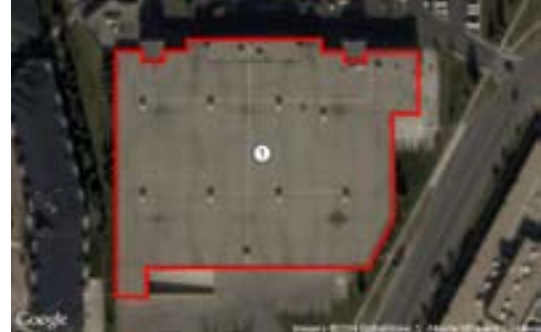
Test Cut 1  
Metal Deck  
1.5" PolyISO insulation  
1.5 PolyISO Insulation  
.045 EPDM

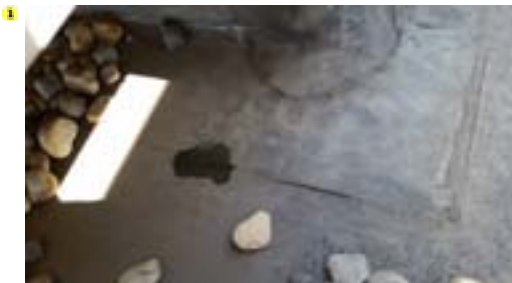
**General - Previous Repair Failure (Emergency)**  
Quantity: 1 EA  
**Deficiency:**  
Existing repair failing due to age or improper repair.  
**Corrective Action:**  
We will remove the existing repair, clean and prime area and install new patch to ensure water tightness.  
**Estimated Repair Cost:**  
\$350.00

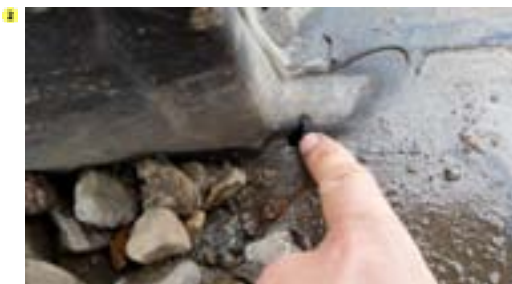
**General - Punctures - Rips - Tears (Emergency)**  
Quantity: 1 EA  
**Deficiency:**  
These deficiencies are typically caused by foot traffic, mechanical work, or simply by a waterproofing membrane that is at the end of its service life and can no longer withstand the weathering and building movement.  
**Corrective Action:**  
The area surrounding the deficiency must be cleaned. A new piece of waterproofing membrane would be installed and sealed per industry standards.  
**Estimated Repair Cost:**  
\$325.00

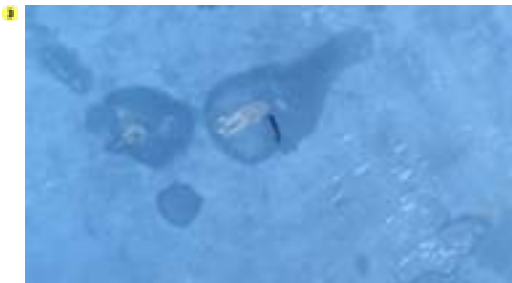
#### FCS Deficiencies - Puncture hole (Emergency)

Puncture hole in membrane

Clean membrane with manufacturers recommended cleaner and install EPDM membrane patch over the existing puncture hole.

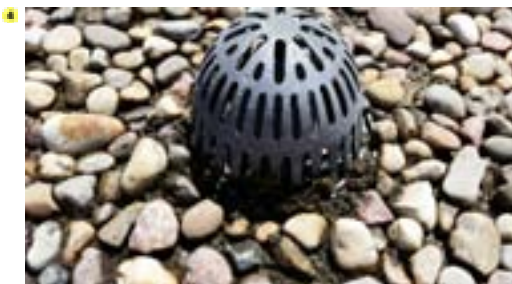
#### General - Clogged Scupper/Drain/Gutter (Remedial)

The existing scupper, drain, or gutter has become clogged and is no longer functioning properly.

The scupper, drain, or gutter area must be cleaned and all debris removed to ensure water drains from the roof properly. This is to be part of a routine roof maintenance program.

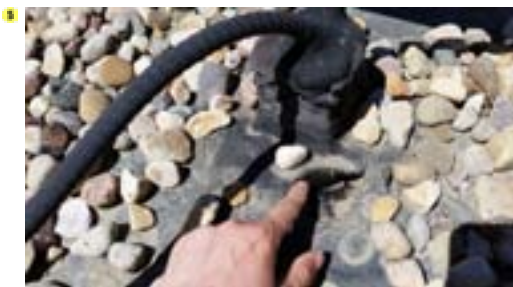
#### FCS Deficiencies - Open Flashing (Emergency)

Open flashings can be caused by membrane shrinkage, insufficient counterflashing or the simple aging and failure of the original flashing to remain adhered to the wall.

Depending on the severity of the deterioration of the flashing, they either will need to be removed completely and new flashing installed or the existing flashing must be re-sealed to the wall and the tops of the flashings covered up.

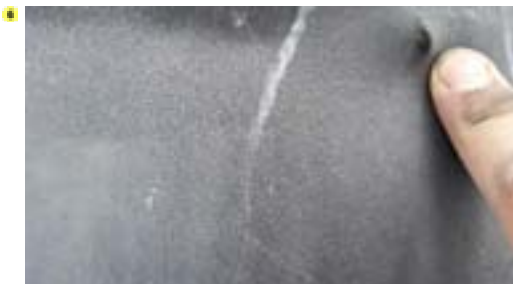
#### EPDM - Fastner Backout (Remedial)

The fasteners and stress plates used to attach thermal insulation and membranes are subject to back-out. This may be due to stripping the fastener out of the deck by over-torque during application, or by the repeated billowing of the membrane under wind load.

If the fasteners are lifted and are puncturing the membrane, the membrane should be slit, the fastener (and stress plate if distorted) removed, and a new fastener installed (but not in the same deck hole). The slit area is then patched using the cleaning, priming and patching techniques.

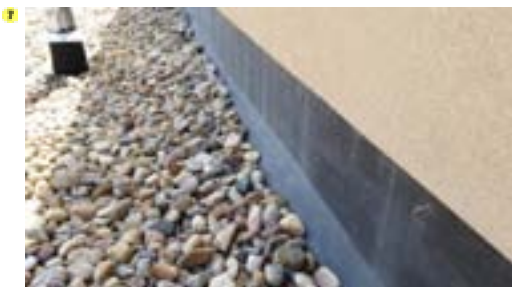
#### FCS Deficiencies - Tenting (Remedial)

Tenting of the membrane is caused by the overall shrinking that takes place over time. The shrinking of the membrane causing it to pull away from perimeter walls and cause stress of the flashing areas of the roof.

The existing membrane would need to be cut, then fastened down with screws and plates in the field of the roof. Install a waterproofing membrane at the perimeter wall and tie membrane into the field of the roof

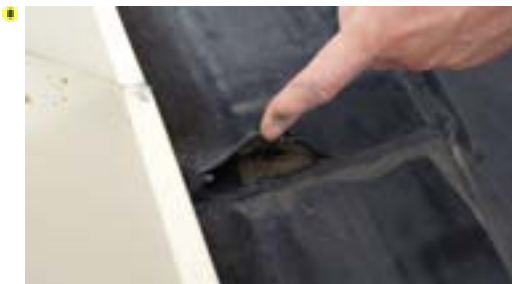
#### FCS Deficiencies - Open Flashing (Remedial)

Open flashings can be caused by membrane shrinkage, insufficient counterflashing or the simple aging and failure of the original flashing to remain adhered to the wall.

Depending on the severity of the deterioration of the flashing, they either will need to be removed completely and new flashing installed or the existing flashing must be re-sealed to the wall and the tops of the flashings covered up.
