## Renoteck Management Report

Your Company  
General Store  
1234 Avenue, Calgary, AB

**General Store  
1234 Avenue  
Calgary, AB**

**Section:** Main Roof  
**Size:** 121,979  
**Overall Grade:** C

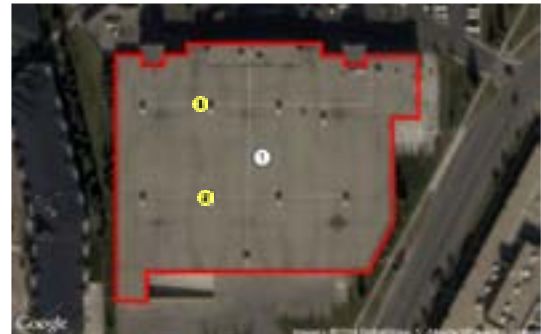
**General - Previous Repair Failure (Emergency)**  
Quantity: 1 EA  
**Deficiency:**  
Existing repair failing due to age or improper repair.  
**Corrective Action:**  
We will remove the existing repair, clean and prime area and install new patch to ensure water tightness.  
**Estimated Repair Cost:**  
\$350.00

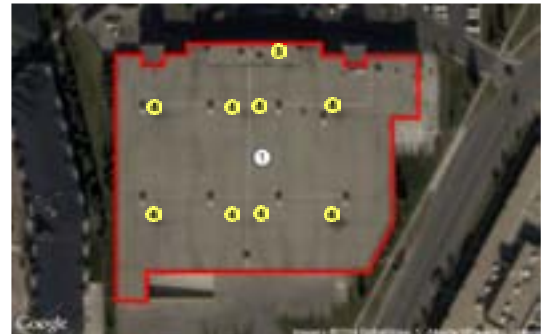
#### FCS Deficiencies - Puncture hole (Emergency)

Puncture hole in membrane

Clean membrane with manufacturers recommended cleaner and install EPDM membrane patch over the existing puncture hole.

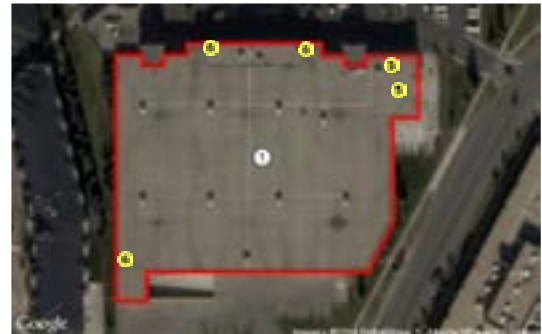
#### FCS Deficiencies - Open Flashing (Emergency)

Open flashings can be caused by membrane shrinkage, insufficient counterflashing or the simple aging and failure of the original flashing to remain adhered to the wall.

Depending on the severity of the deterioration of the flashing, they either will need to be removed completely and new flashing installed or the existing flashing must be re-sealed to the wall and the tops of the flashings covered up.

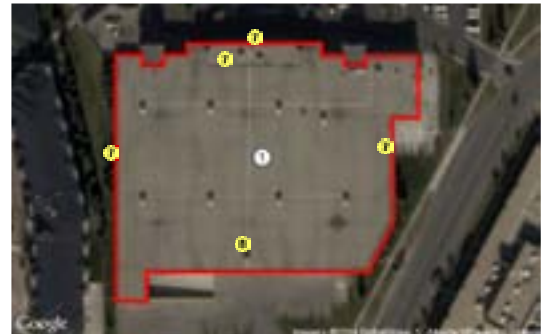
#### FCS Deficiencies - Tenting (Remedial)

Tenting of the membrane is caused by the overall shrinking that takes place over time. The shrinking of the membrane causing it to pull away from perimeter walls and cause stress of the flashing areas of the roof.

The existing membrane would need to be cut, then fastened down with screws and plates in the field of the roof. Install a waterproofing membrane at the perimeter wall and tie membrane into the field of the roof
